TECHNICAL NOTE 2865

INVESTIGATION OF GASES EVOLVED DURING FIRING OF VITREOUS COATINGS ON STEEL

By Dwight G. Moore and Mary A. Mason
National Bureau of Standards

Washington January 1953

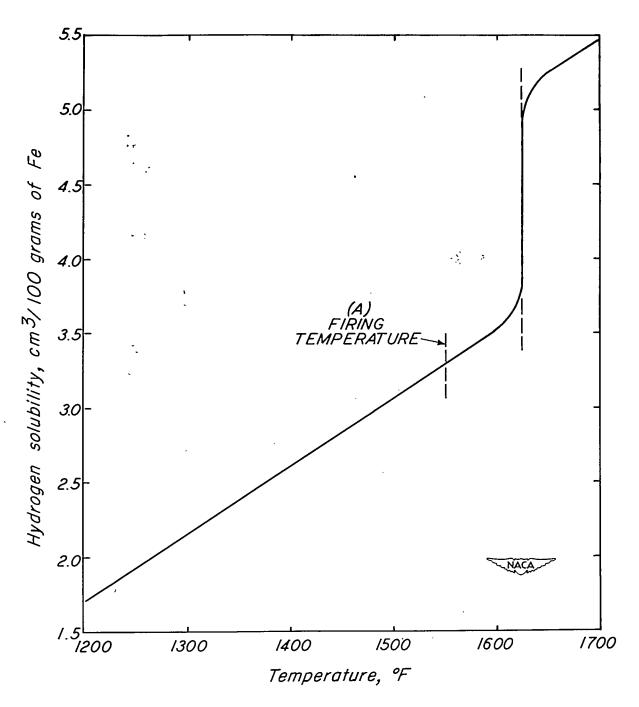
Table 4 shows that primary boil began in these experiments when the temperature of the metal reached about 1400° F. At this stage of the firing, the enamel is in a molten condition but is not yet in contact with the metal. Figure 4 shows that the scale layer that formed on the iron prior to fusion of the enamel has not as yet been dissolved when the primary-boil blisters first appear. Thus, it appears that the oxygen necessary for oxidizing the carbon in the steel must come from the scale layer. Porter and Rosenthal (reference 5) stated in their study with cast iron that it appeared that gassing occurred only when free iron oxide was present at the iron surface. Pennington (reference 6), in his investigation of the thermodynamics of decarburization of steel by mill scale, determined that the evolution of carbon-oxygen gases (CO and CO2) from a sealed box containing preoxidized steel specimens started suddenly at about 1300° F and continued quite satisfactorily at 1450° F. Thus, the probable cause of primary boil is believed to be as follows: During the heat-up period (before the enamel fuses) a scale layer forms on the steel. When a temperature of about 1300° F is reached, the enamel has melted and wet the scale layer but before it can dissolve the scale a reaction begins between the scale layer and the carbon in the underlying metal. This reaction produces CO and CO2 to give the gas evolution known as primary boil. After the scale has been dissolved by the enamel, no appreciable reaction takes place and the primary boil stops. At this stage the outermost surface of a low-carbon steel is probably substantially free of carbon. With a high-carbon steel, on the other hand, there may still be sufficient carbon at the surface to cause a continued oxidation of carbon by the oxygen diffusing through the enamel layer. Therefore, with a high-carbon steel blistering might be expected to occur throughout the normal firing period. Actually this is the condition found with the specimens that had been case-carburized before coating.

Figure 4.- Photomicrograph (X1000, unetched) of coating-iron interface at the primary-boil stage of firing. Note oxide layer at interface.

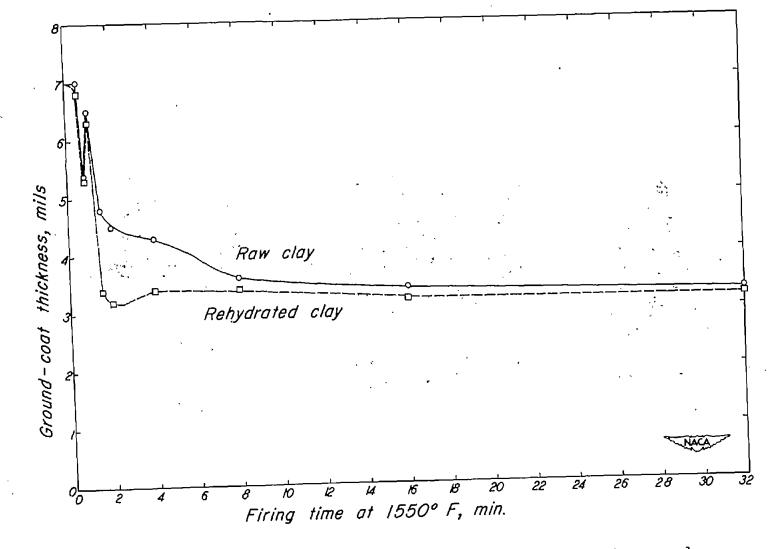
Figure 6 shows the resulting bubble structure after a 4-minute firing at 1575° F for the coatings prepared with Florida kaolin. The results were substantially the same for the German Valendar clay except that in this case there was no specimen available to represent the rehydrated clay. It is apparent from figure 6 that the clay mill addition is largely responsible for the bubble structure observed in a normally fired enamel. Further, the results show that there is some bubbleforming constituent present in the raw clay that is removed by the heat treatment at 1000° F. That this constituent cannot be the chemically combined water is evident by comparing figure 6(c) with 6(a). If the bubble formation is related to the chemically combined water, both enamels should show approximately the same bubble structure. Because there is much less bubble structure in the enamel prepared from the rehydrated clay, the bubble structure of a normally fired enamel must therefore be associated with impurities that are present in the raw clay. These impurities could be adsorbed carbonaceous material, possibly tannin in some form, or the impurities could be carbonates of calcium and magnesium. A typical analysis of the Florida plastic kaolin shows 0.20 weight percent of magnesium oxide (MgO) and 0.15 weight percent of calcium oxide (CaO). Higgins (reference 12) was able to duplicate the type of bubble structure obtained with enameling clays by adding small amounts of methylene blue at the mill. Because of these results he concluded that the bubble structure imparted by enameling clays is apparently due to their organic-material content.

(c) Clay heated 20 hours at 1000° F followed by autoclaving for 300 hours at 406° F.

Figure 6.- Photomicrographs (X26, oblique illumination) of surface of coated ingot-iron specimens after normal firing. Coating in (a), (b), and (c) was identical except for treatment of Florida kaolin mill addition used for suspending the slip.
